Manhole Inspection Summary

Manhole # S45KK_004MH

Insp Date: **4/15/08 8:20 AM**

Location Address: **Chester St**

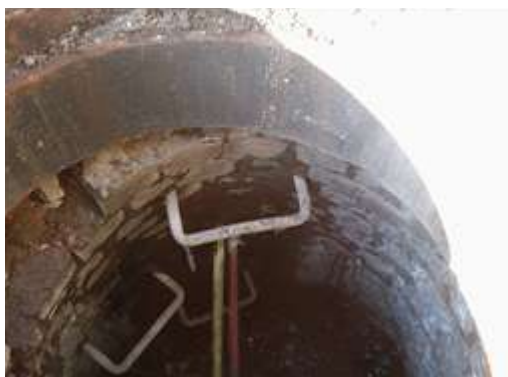
Defect 2

Frame Offset: **4** (in.) Condition: ☐ Sound ☐ Cracked ☒ **Leaks**

Frame Leaks

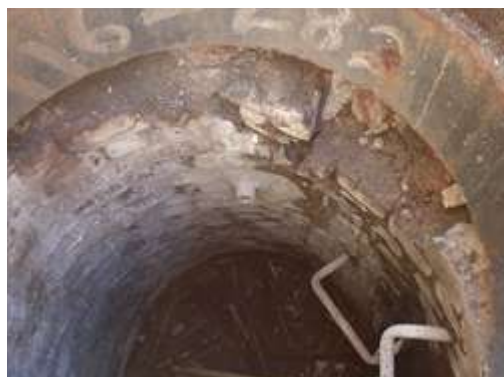
Defect 1

Condition: ☐ Sound ☐ Cracked ☐ Root Intrusion ☒ **Loose Brick** ☒ **Deteriorated**

Loose Bricks

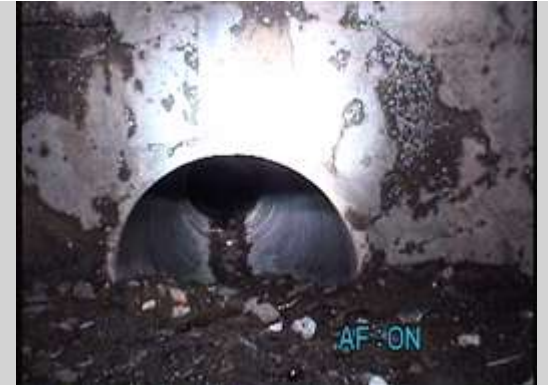
12 O'Clock Outflow

8 in. Circular Gravity Sewer
Pipe Out @ 12 O'Clock

Deposits: ☐ None ☒ **Mud** ☒ **Gravy** ☒ **Debris** ☐ Grease

Silt Depth: **4** (in.) Deposits Extent: **Medium**
